**Shoalhaven City Council
Coastal Zone Management
Study and Plan**

Coastal Slope Instability Hazard Study

FINAL Report

Document Number 3001209-020

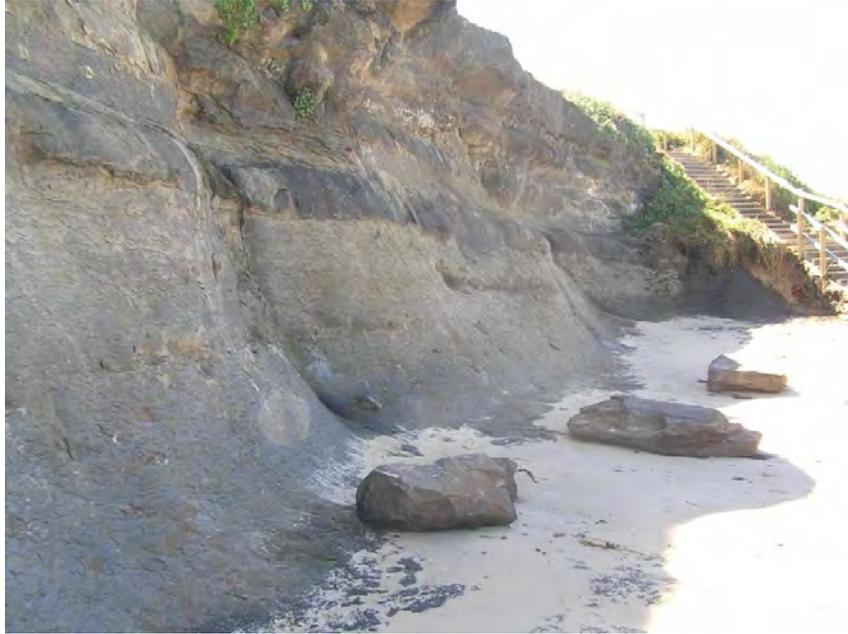
- The car park is separated from the cliff by a fence situated 1-3m from the edge of the cliff.
- The slope varies in height up to approximately 20m and dips to the east between 60°-90° (typically 70°) and is undercut in areas below the beach access steps, see Photograph 3.1 below.

Photograph 3.1 shows an undercut cliff and shelf below car park and adjacent to beach access steps at Racecourse Beach.

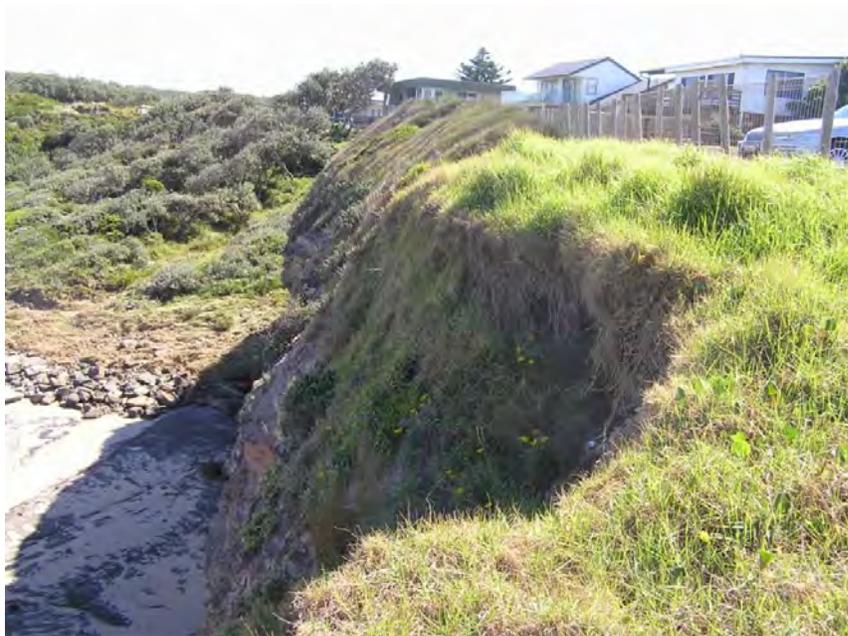
- The upper slope is vegetated by grass and Bitou Bush with scarce vegetation along the sub-vertically dipping lower slope, see Photograph 3.2 below.

Photograph 3.2 is taken looking to the south along the crest of the cliff adjacent to the car park at Racecourse Beach.

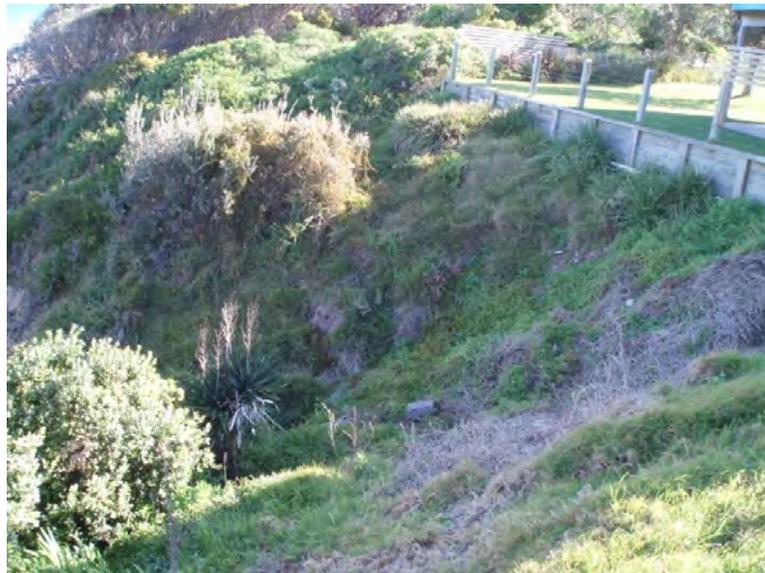
- Highly weathered sandstone was evident at the toe of the slope.
- The southern slope dips approximately 40° from the crest becoming much steeper 60°-70° towards the base of the gully. This slope is sparsely vegetated with grass and shrubs and is hummocky towards the crest. Highly weathered sandstone is exposed locally on the slope face due to gully erosion, see Photograph 3.3 below:

Photograph 3.3 shows erosional rills on a steep slope adjacent to a stormwater gully at Rennies Beach. Note the retaining wall of a property above the crest of the gully.

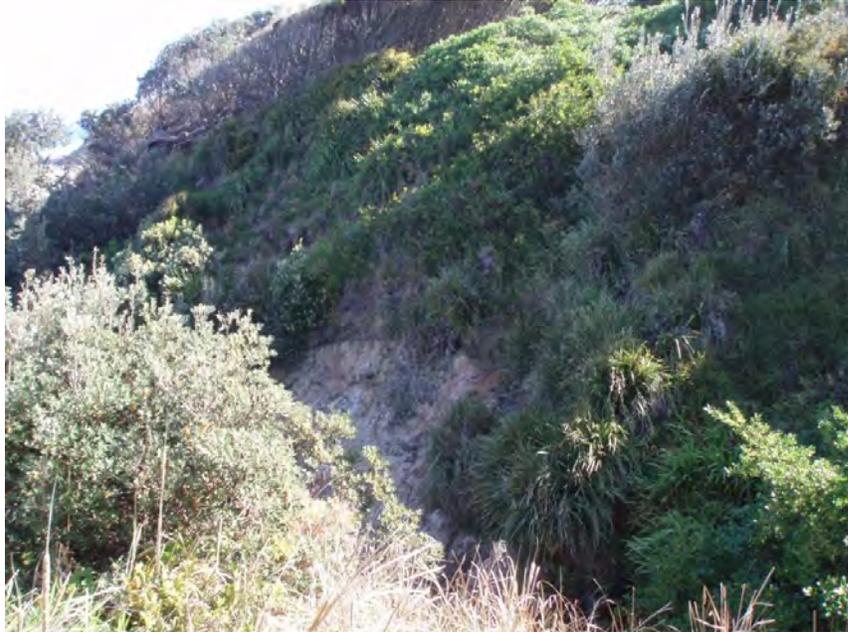
- Small slumps (2m³) and tension cracks were observed in the soil about midway down the slope on the northern side of the drainage path and adjacent to the

Photograph 3.4 shows a $<5\text{m}^3$ slump failure on the southern side of a stormwater drainage gully at Rennies Beach.

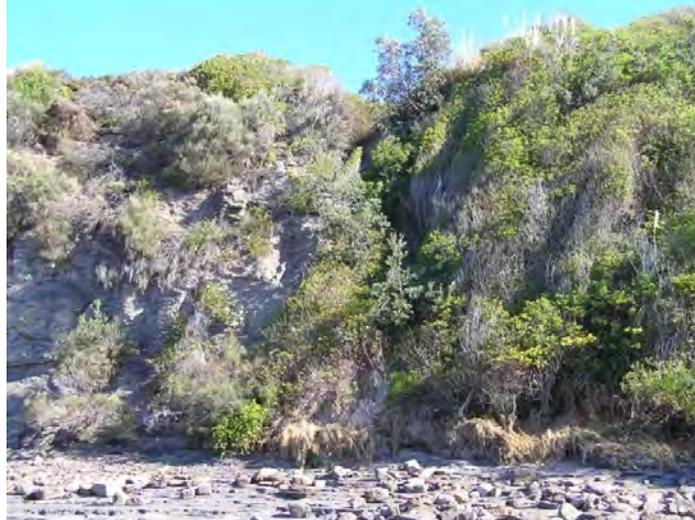
siltstone, and silty sandstone with some lighter grey sandstone units. The bedding has an apparent dip 2° to 5° to the north or north west. The rock mass exposed on the cliff face is generally highly to moderately weathered with the top 5m of the vertical profile which consists of extremely weathered rock to residual soil and underlies the houses at the crest. This portion of the slope has a reasonable vegetation cover except in the areas near the stormwater pipe outlets at the edge of the crest where the material is eroded by the drainage discharge. A deeply incised gully, which extends vertically from the crest to the toe, is evident below a stormwater drainage pipe discharge near the backyard of 63 Nurrawallee Street. The gully has exposed extremely weathered to highly weathered siltstone. Minor slumping was observed within the gully area, see Photograph 3.5 below:

Photograph 3.5 shows a steep gully cutting into the slope at Collers Beach Headland (Nurrawallee Street) directing stormwater from the properties above the cliff to the ocean. Slumping is apparent along the gully sides.

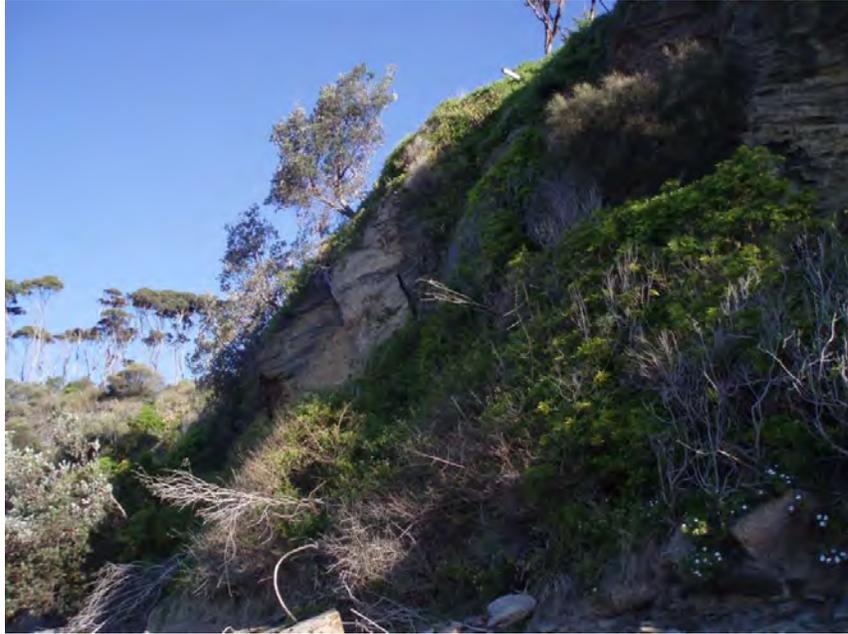
- Two main sub vertical joint sets were observed in the rock platform as well as along the slope. The first or primary joint set strikes sub-parallel to the cliff-line (typical dip/dip direction $85^{\circ}/240^{\circ}$ and $85^{\circ}/060^{\circ}$) with the joint spacing which varies from 0.3m to 2.0m, open to 15mm. The second joint set is orthogonal to the first joint set (with a dip/dip direction of about $90^{\circ}/160^{\circ}$) and has a joint spacing which ranges from 1.5m to 3m (true thickness) with the joint opening up to 15mm wide. A less frequent sub-vertical joint set oriented diagonally to the other two sets is also present in the rock platform and the slope, see Photograph 3.6 below:

Photograph 3.6 shows a loosened jointed block, a tree leaning downslope. The sandstone bedrock appears to dip down slope. Note the open (~100mm) fracture behind the block. A drainage polypipe appears to direct stormwater to the slope from the property above the crest of the cliff.

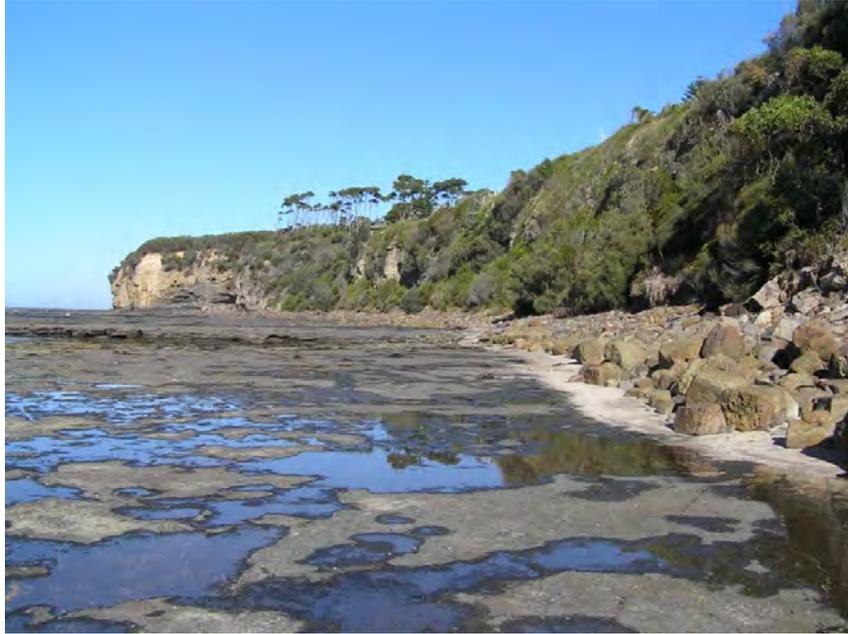
- Presence of unstable blocks of rock mass on the slope
- The moderately to highly weathered siltstone towards the toe of the slope is subject to ongoing wave erosion resulting in slow but continuous undercutting of the headland. This process is aided by the constant wetting and drying of the siltstone and silty sandstone units which results in degradation of these rock types and subsequent underpinning of the stability of the overlying sandstone units.
- Weathering of the toe of the slope is causing undercutting of the overlying jointed siltstone and sandstone units and subsequent toppling failure of the overlying jointed rock mass. As a result of this ongoing process a rock talus curtain of approximately 5m wide has formed along the toe of the slope. The talus includes the rock mass blocks of the size up to 0.5m in maximum dimension, see Photograph 3.7 below:

Photograph 3.7 shows the scree pile of blocks (~0.5m) at the toe of the cliff associated with undercutting action of tidal wave energy causing rock falls at Collers Beach Headland (Nurrawallee Street).

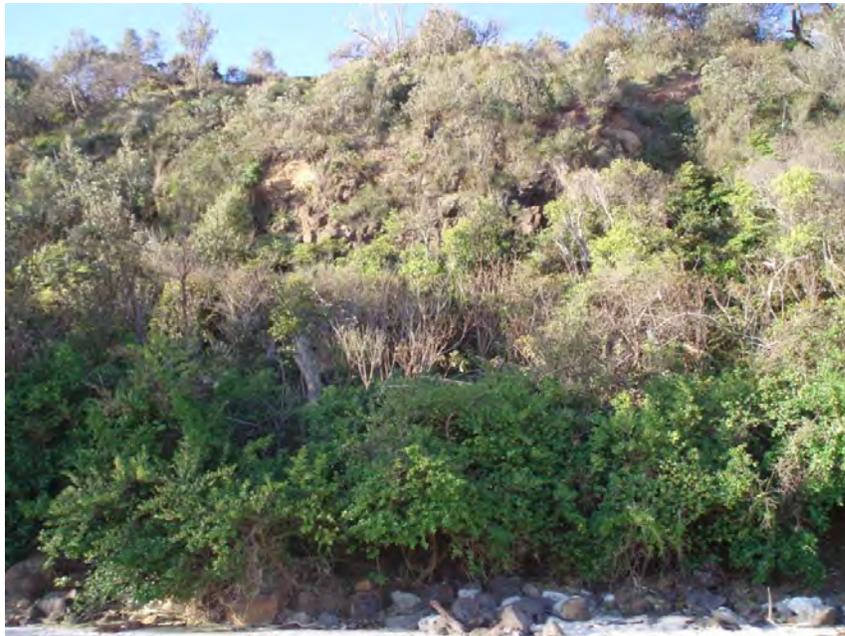
- The slope at the crest dips gently at approximately 10 -15° to the south and becomes steeper to about 55° to 70° lower in the cliff profile. At the inspected site, the slope is approximately 25m high.
- Generally, established vegetation cover on the slope except in localised steeper areas where sandstone is exposed on the sub-vertical face.
- At least one joint set in the sandstone rock mass is apparent sub-parallel to the slope.
- Basalt interpreted from the geological map was not observed on the exposed slope during this inspection.
- Some evidence of past toppling failures from higher parts of the slope with sandstone blocks lying at the base, typically blocks 1.0m to 1.5m in size, see Photograph 3.8 below:

Photograph 3.8 shows a thickly vegetated slope with blocks (~0.3m) at the toe of the slope and rugged blocky sandstone towards the crest of the slope.

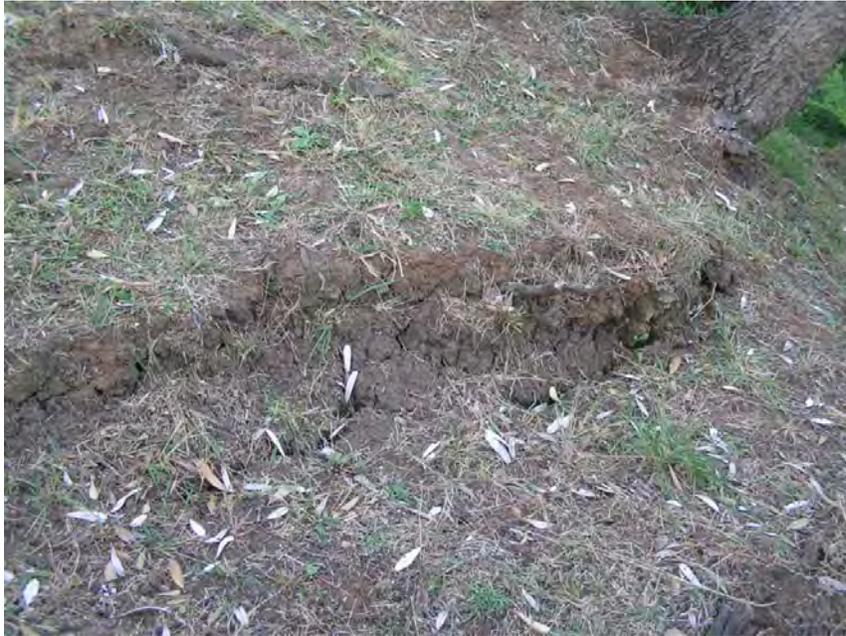
- Overland runoff has caused erosion of the unconsolidated soil in the upper slope and water infiltration has resulted in soil creep, see Photograph 3.9 below:

Photograph 3.9 shows a destabilised section of soil towards the crest of the slope resulting in soil creep. Trees in this area were also observed to be leaning downslope.

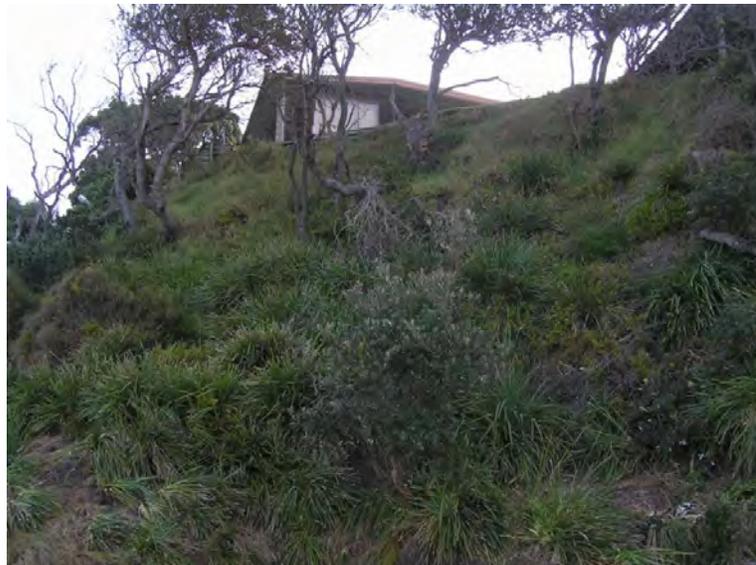
- Siltstone headland 10m to 12m high, typically 50°-60° but near vertical where undercut, see Photograph 3.10 below:

Photograph 3.10 shows a house with a retaining wall adjacent to the crest of a steep slope at Berrara Headland.

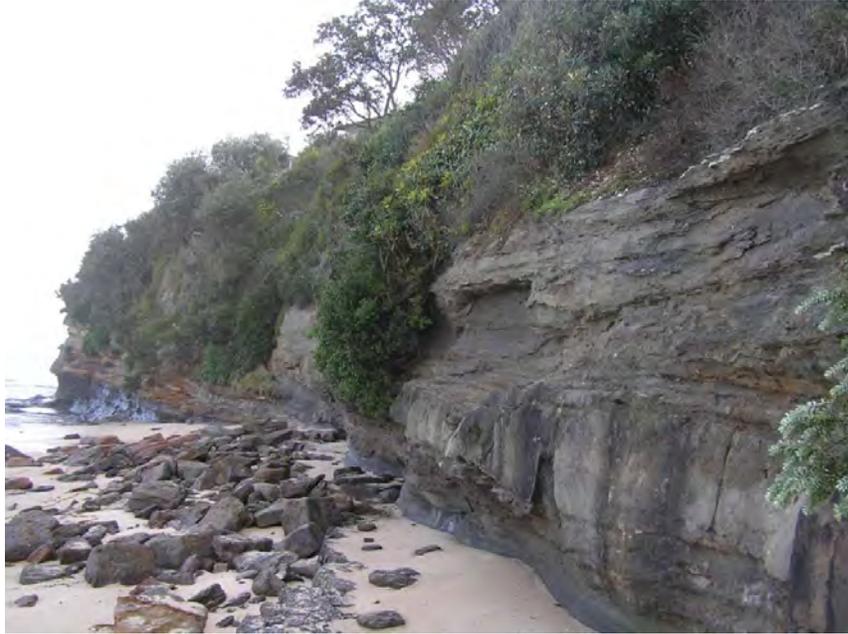
- Jointing appears to be sub-parallel to the headland with an orthogonal joint set.
- The headland is actively being eroded by the wave action at high tide causing undercutting and block failure from the overlying units, see Photograph 3.11 below:

Photograph 3.11 shows a steep slope underlain by hard rock. Note the undercutting of the siltstone at the toe of the slope in the distance at Berrara Headland.

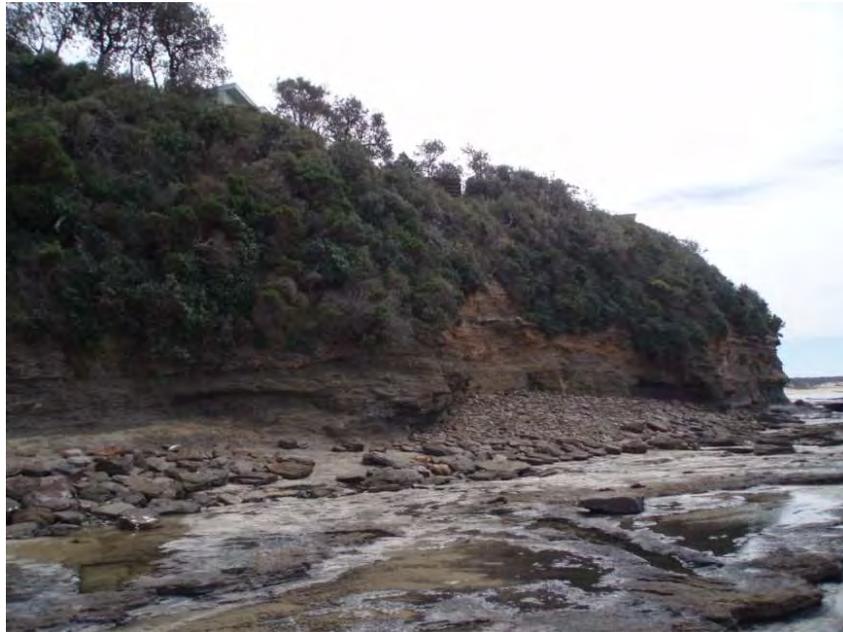
- Sandstone units located above the typically siltstone slope and wave platform are undercut.
- In areas the build up of talus at the toe of the slope is up to 2m thick comprising blocks up to, but typically less than, 1.5m in diameter, see Photograph 3.12 below:

Photograph 3.12 shows blocks to 300mm and blocks to 1.0m and 1.5m in the talus pile at the toe of the cliff at Berrara Headland.

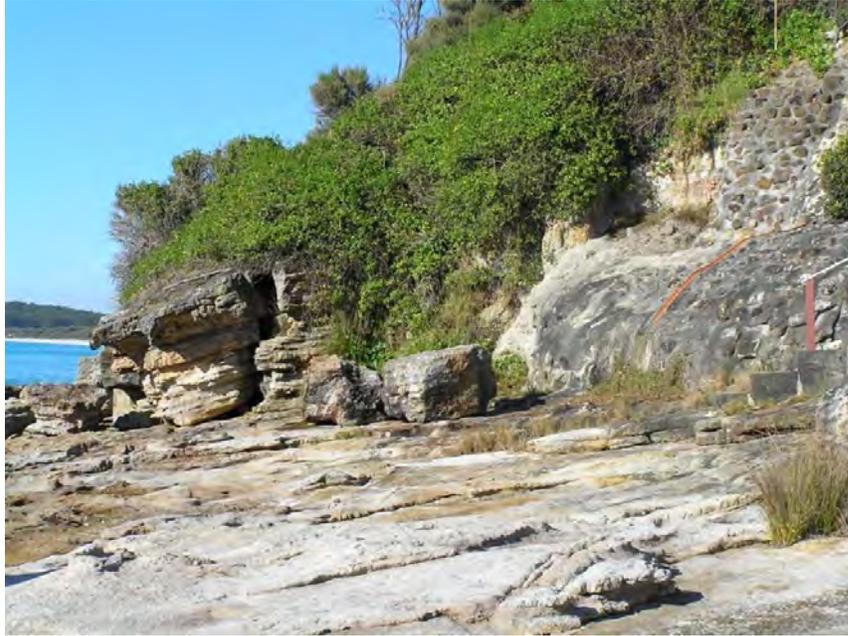
- Slope dips 30-60° to north east and appears stable.
- Houses well back from the crest of the slope.
- Rock fall observed around Hyams Point headland, see Photograph 3.13 below:

Photograph 3.13 shows an unravelled sandstone blocks at the toe of the slope at Hyams Point.

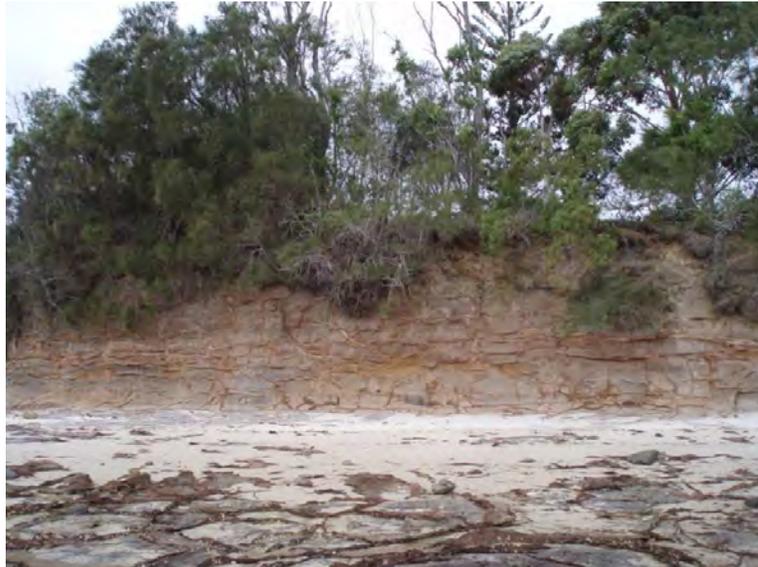
- Wave action at high tide is actively undercutting the headland.
- The slope is formed in the moderately weathered grey silty sandstone and siltstone.
- Numerous rotational failures were noted along the headland 3-4m high with notable tree instability from the crest, see Photograph 3.14 below:

Photograph 3:14 shows that coastal processes have weathered the toe of the bluff and toppling failure of the overlying weathered rock, soils and trees has resulted.

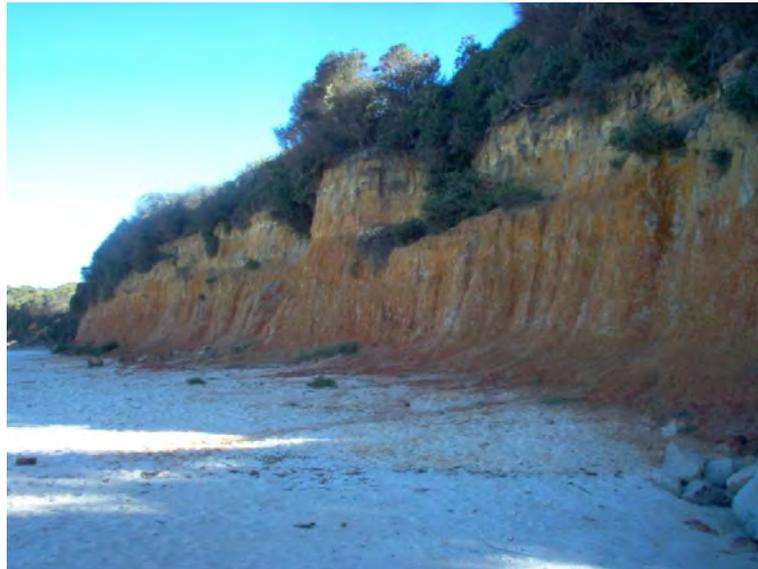
- Storm scour has eroded the extremely to highly weathered pebbly sandstone at the toe of the bluff and undercut the top two metres under the crest.
- The beach at low tide is typically >30m from the toe of the bluff.
- Failures including blocks to 0.5 metres and approximately five cubic metre debris slides were observed.
- Water seepage was observed from bedding planes at the toe of the bluff.
- Sections of the bluff have been eroded to within five metre of the road (Nelsons Beach Parade).
- Nature walk path appears to be some ten metres from the crest of the bluff to the south of Nelson Beach Parade.
- Vegetation located in front of residential properties along Nelsons Beach adjacent to the crest of the bluff has been removed or perished.

Photograph 3:14a shows that coastal processes have weathered the toe of the bluff and toppling failure of the overlying weathered rock, soils and trees has resulted.

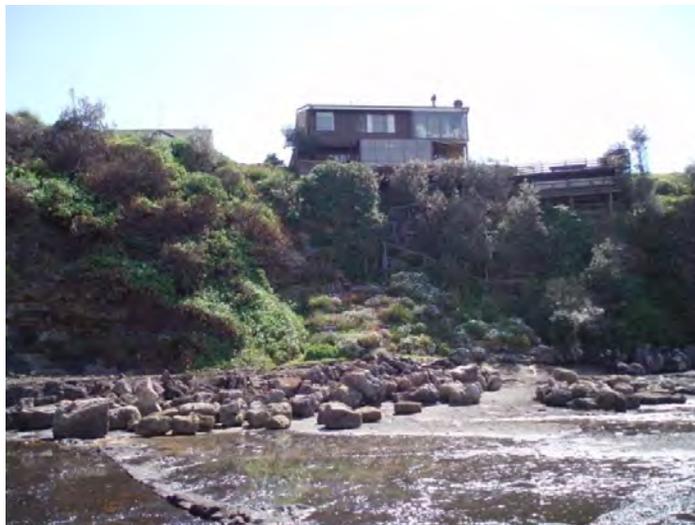
- F2 – 53°050°: 200mm displacement.
- Bedding dips approximately 3°/135°, open sub-vertical joints may result in toppling failure of headland rocks.
- Sandstone blocks to 1.2m in size toppling from the jointed cliff line, see Photograph 3.15 below:

Photograph 3.15 shows blocks (1.5m) accumulated at the toe of the bluff.

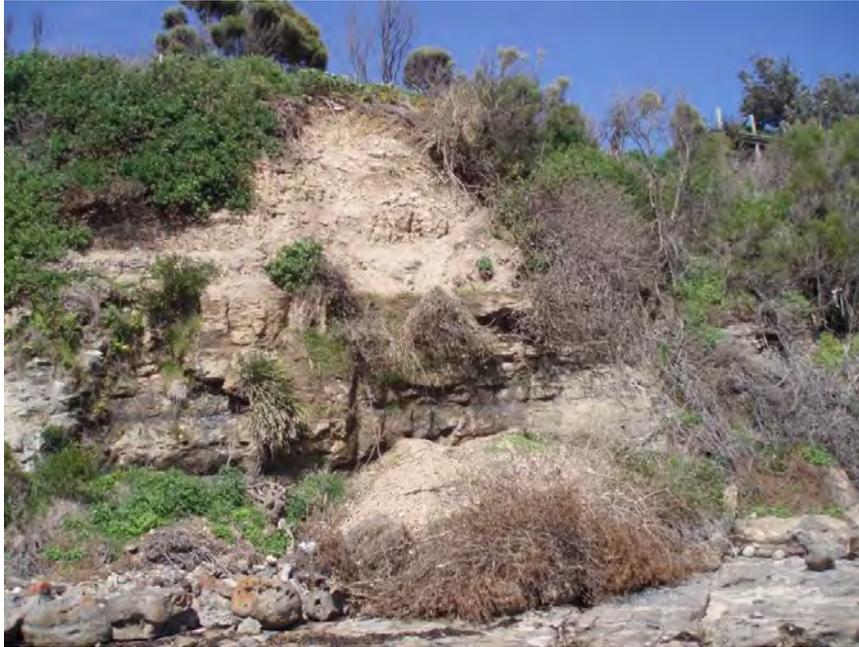
- Sections of the northern slope appear to be unravelling however the vegetation is quite thick and trees are not leaning down slope.
- 200m from the headlands eastern tip comprises jointed siltstone undercutting along the cliff-line.
- Debris slide/topple ($5\text{-}20\text{m}^3$) due to water infiltration into soil at the crest and coastal processes eroding the siltstone towards the toe of the slope, see Photograph 3.16 below:

Photograph 3.16 shows a recent debris topple ($<5\text{m}^3$) event at Penguin Headland.

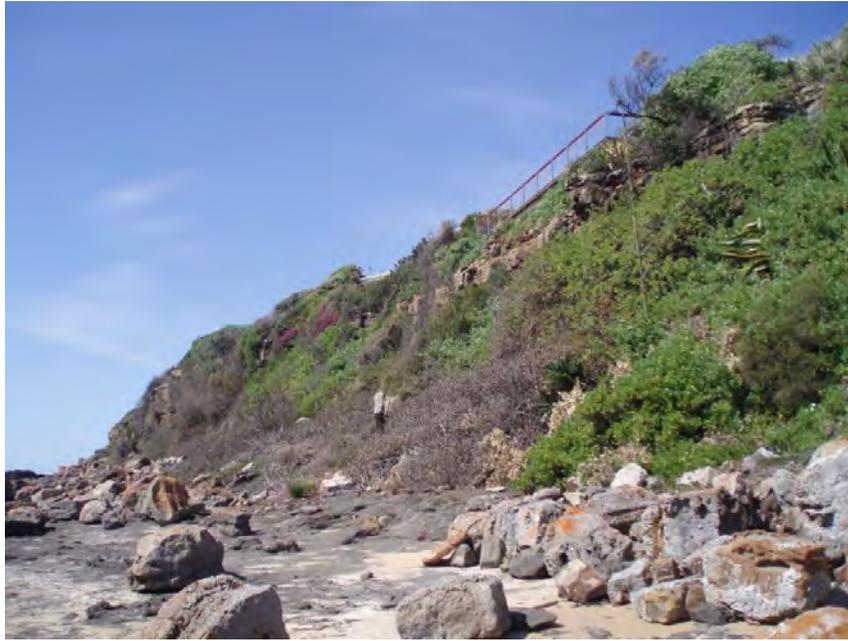
- The houses around the headland are typically greater than 10m away from the crest of the slope, however, a few residences are approximately 5m from the slope crest, see Photograph 3.17 below:

Photograph 3.17 shows a property fence adjacent to the crest of the bluff.
